Dam Safety Inspection Report

Lower Lake Miramichi Dam

Dam I.D. 0017

INSPECTION DATE: October 31, 2023

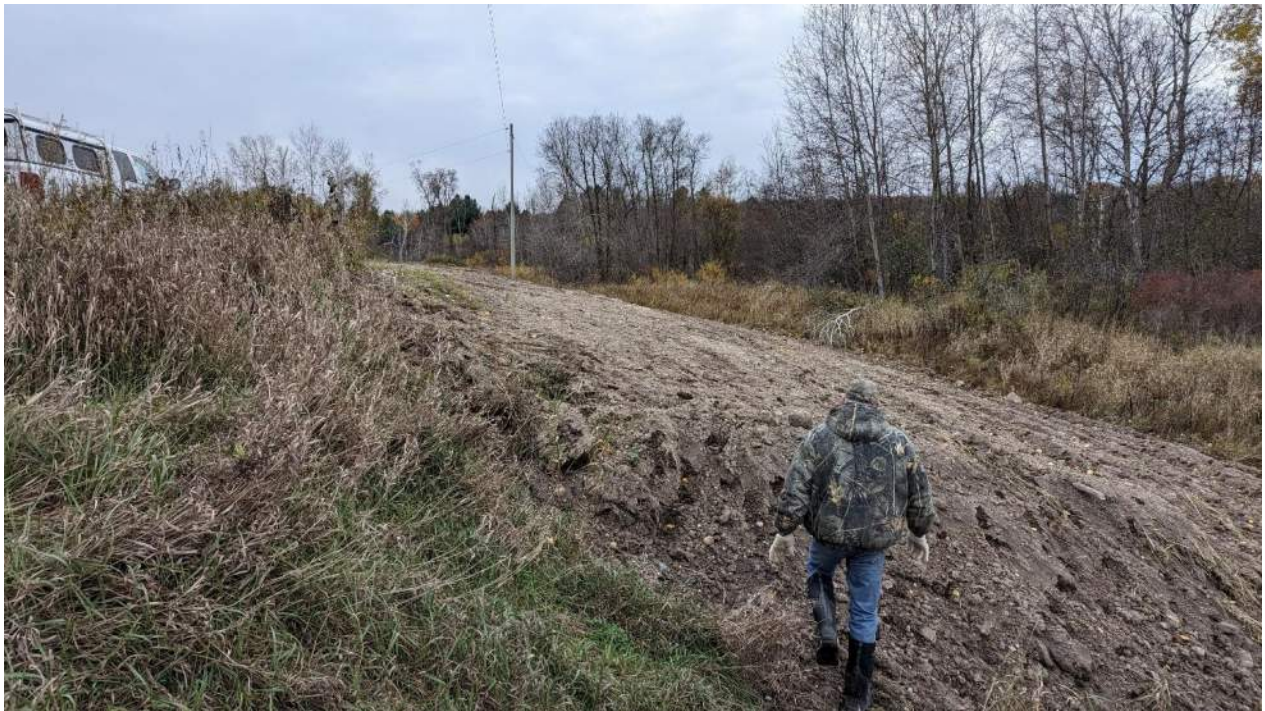
Figure 1: Downstream Embankment Looking Left from Outlet

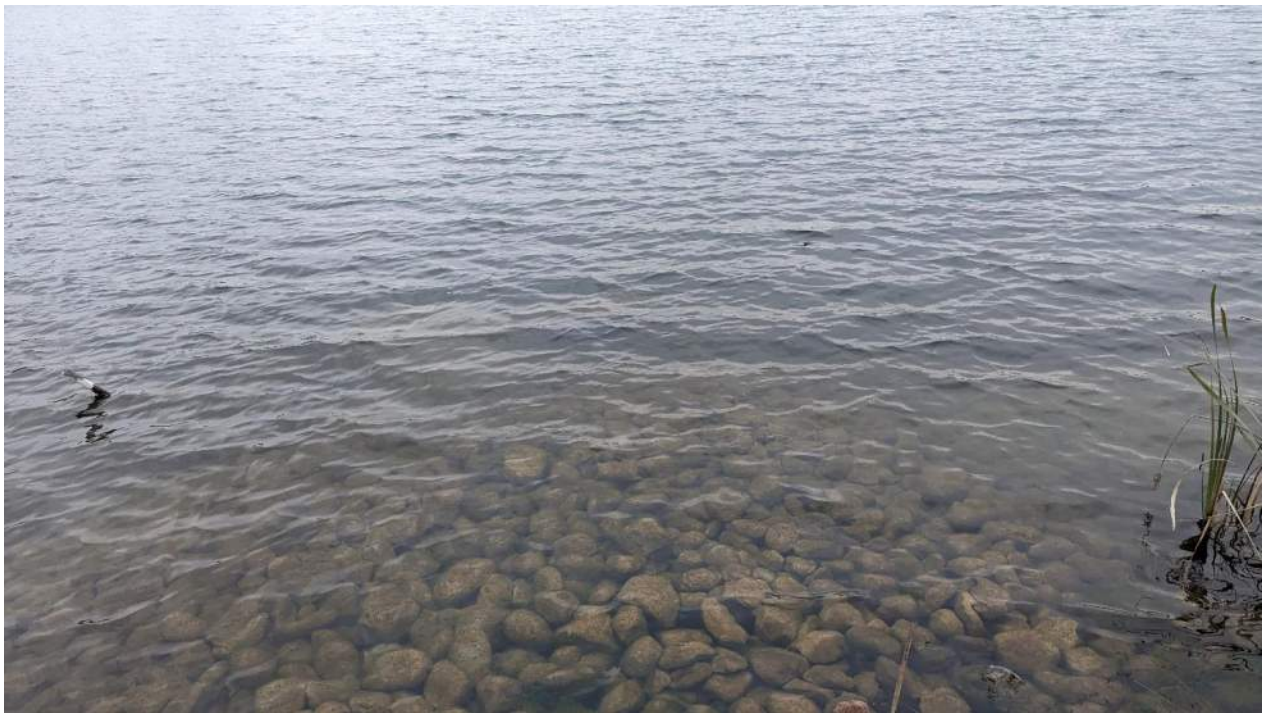
Figure 2: Inlet Pipe in Lake Miramichi

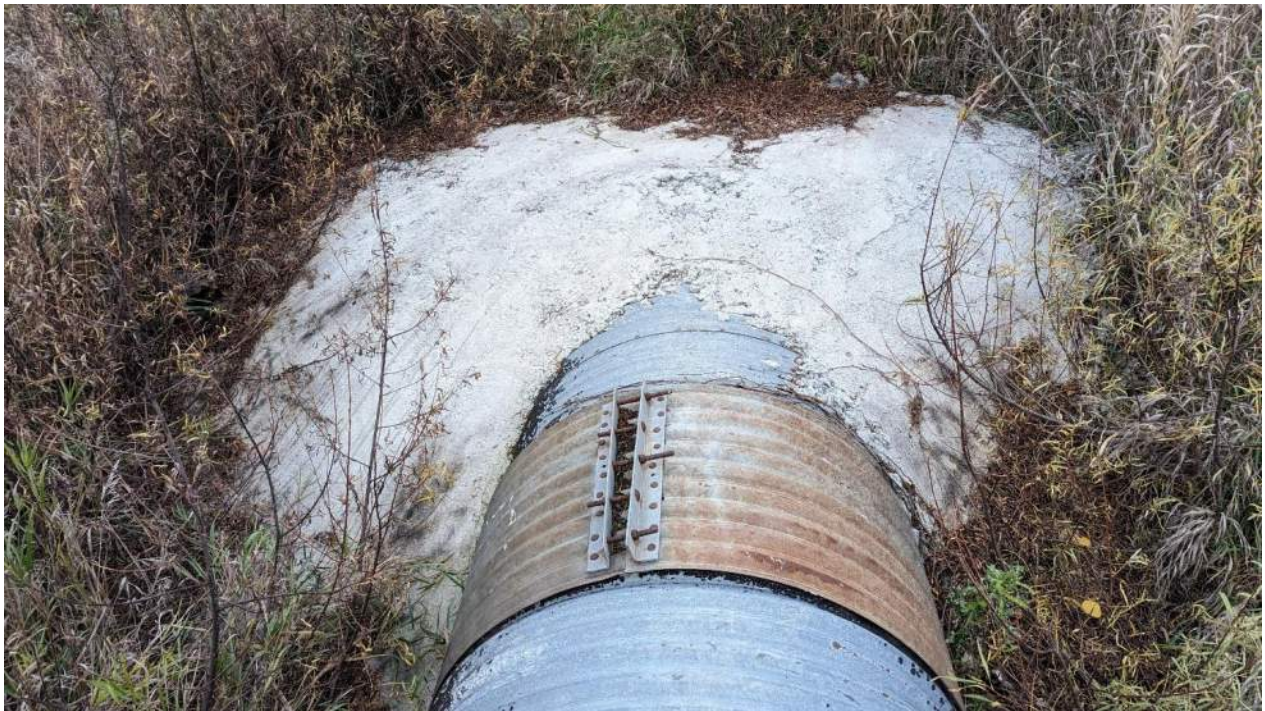
The service spillway is a drop inlet structure. The concrete inlet box measures 11.2 feet by 11.2 in plan. It has a 4-foot wide Lift gate and wooden stop log bay. After water drops over the stop logs, the water discharges through a 48-inch diameter corrugated metal pipe (CMP). Outflow drops into a stone lined stilling basin. The stop logs and the interface between the 48" pipe and the downstream bank have been reinforced using concrete since the last inspection.

Figure 3: Concrete Poured at outlet pipe/embankment interface

7. Riprap at the bottom of the outlet pipe/stilling basin should be inspected and replaced as necessary.

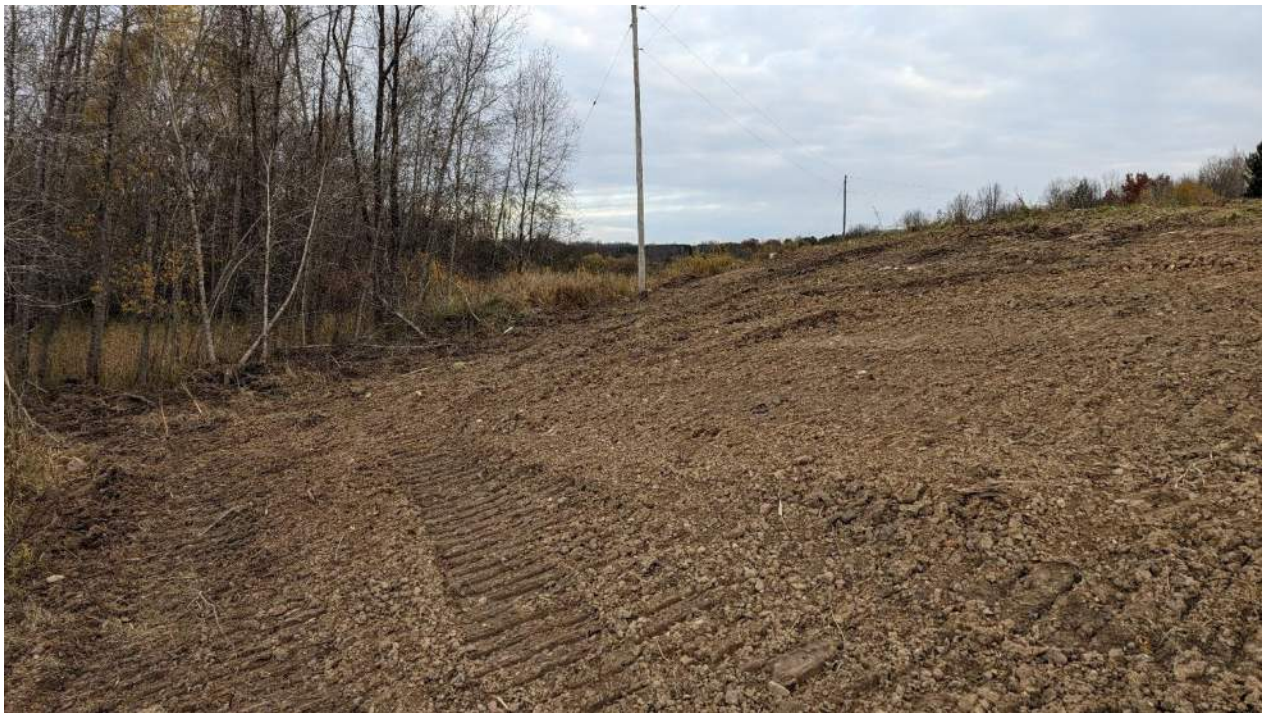
Figure 4: Downstream Embankment Looking Right

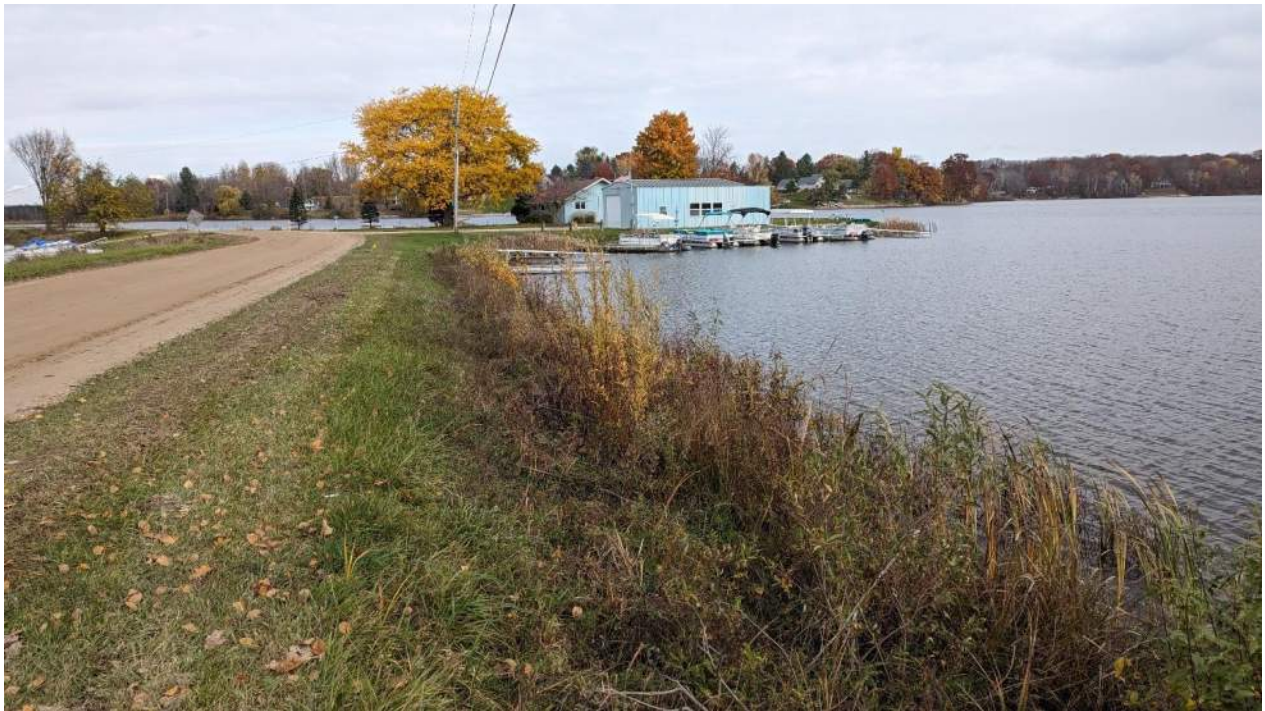
Figure 5: Upstream Embankment Looking Right Near Lake Miramichi Marina

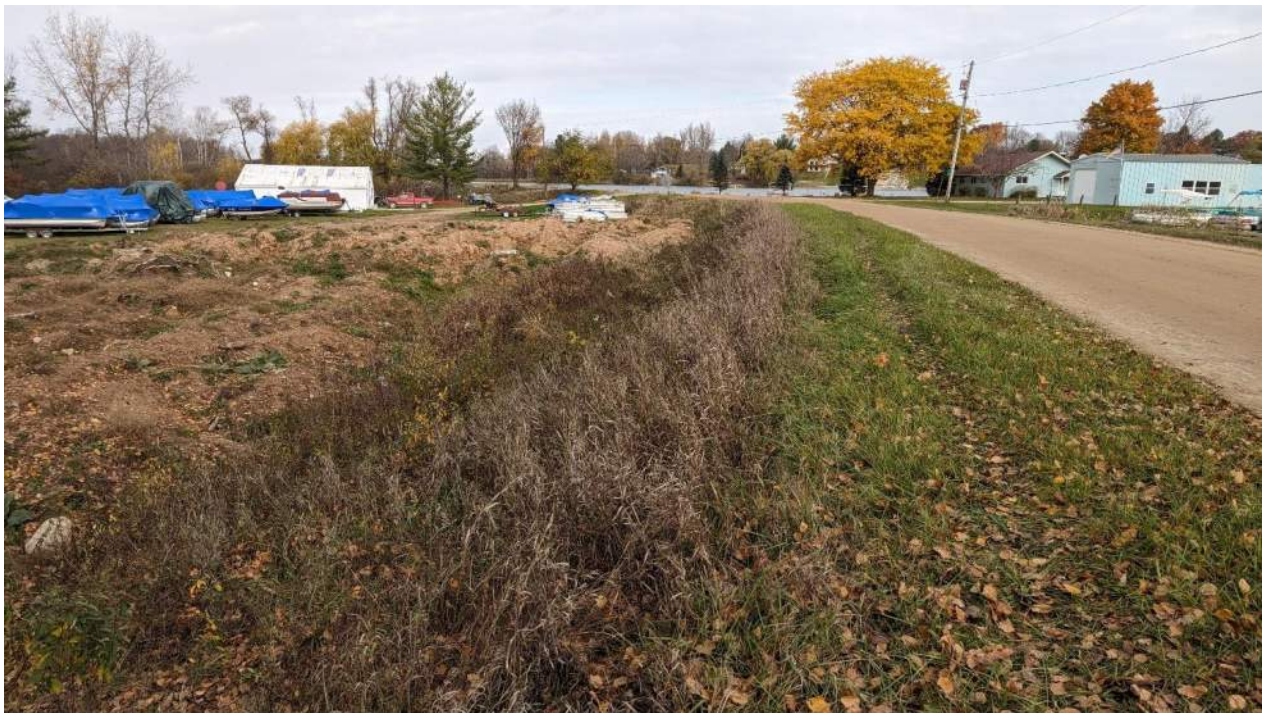
Figure 6: Downstream Embankment Looking Right Near Lake Miramichi Marina

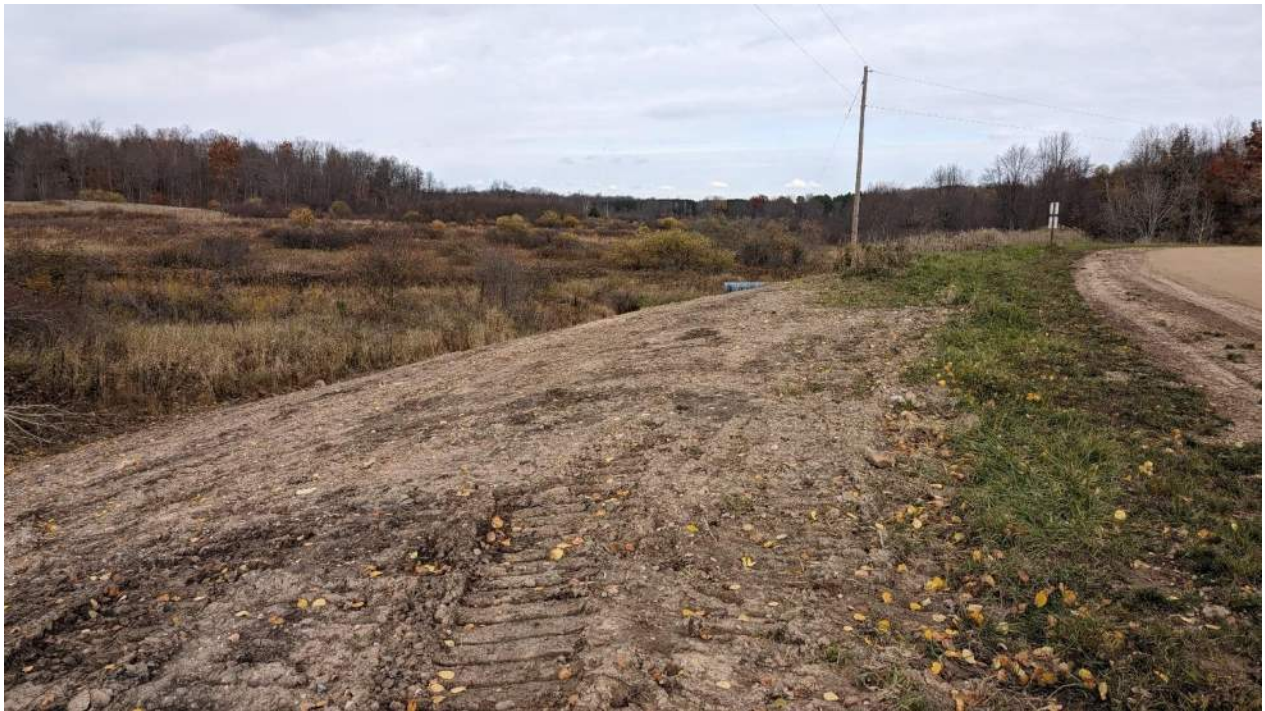
Figure 7: Downstream Embankment Looking Right Near Control Structure

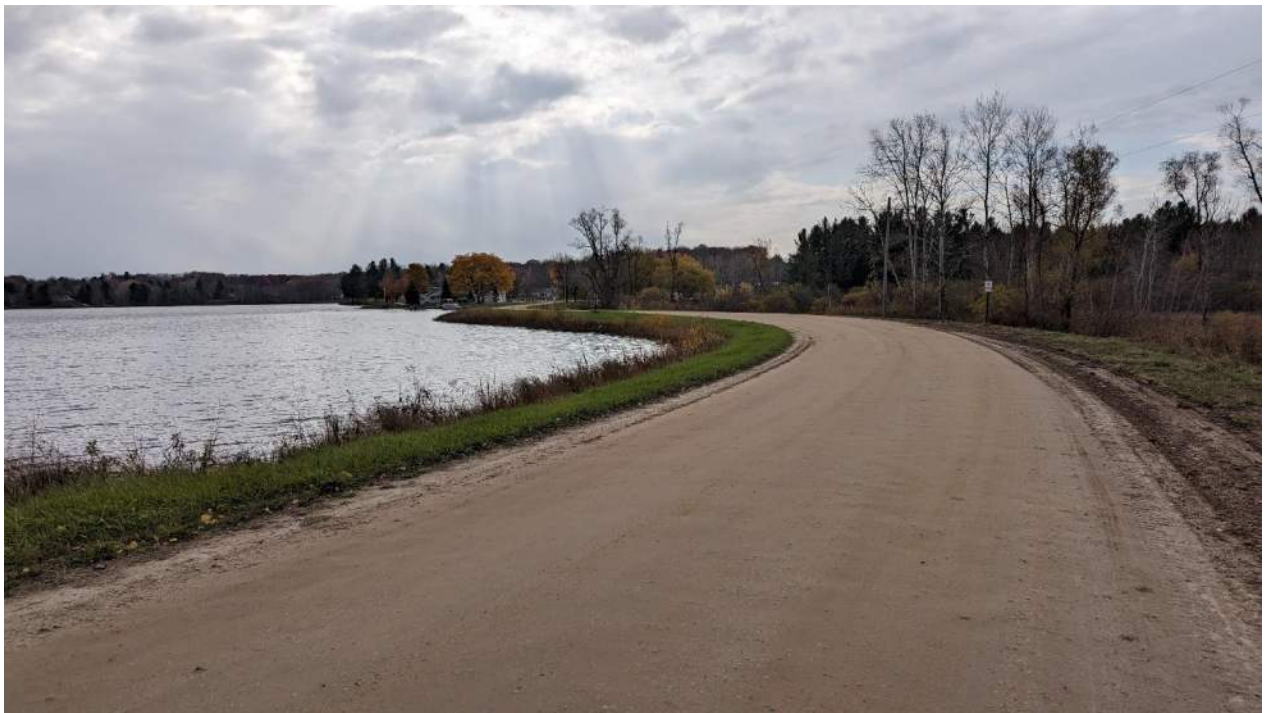
Figure 8: Embankment Crest Looking Left from Control Structure

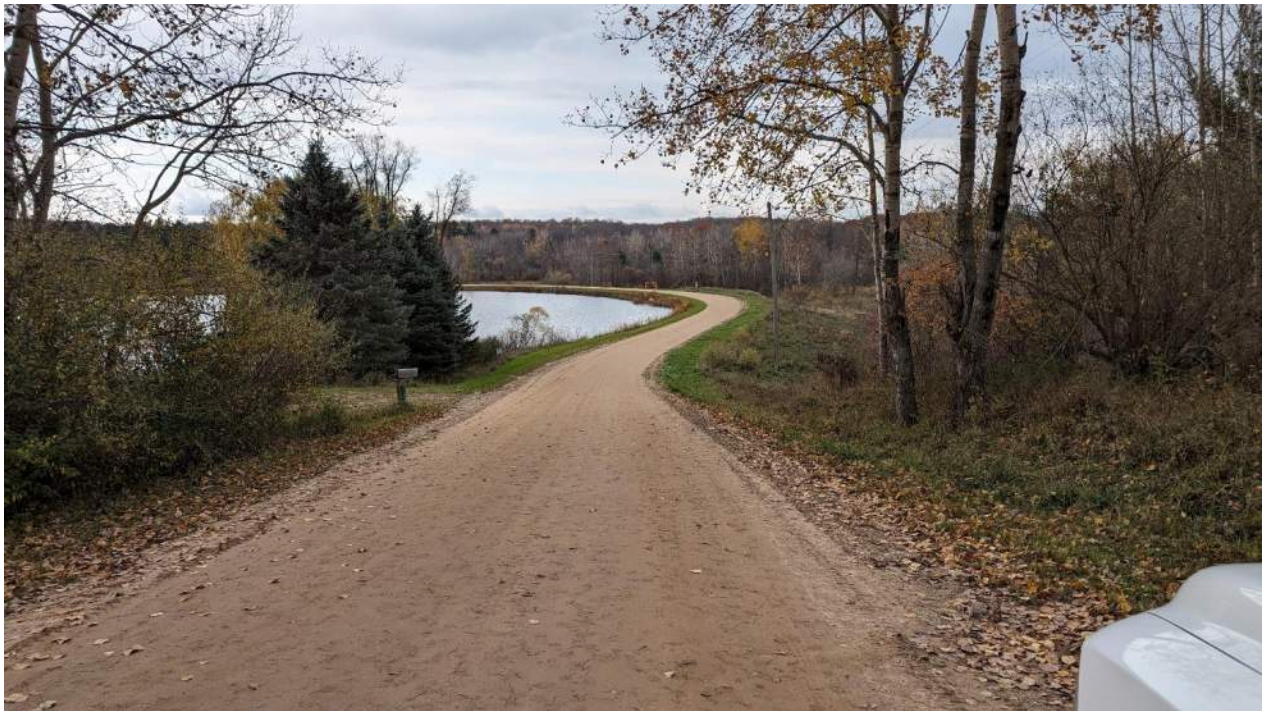
Figure 9: Dam Crest and Upstream Embankment Looking from North

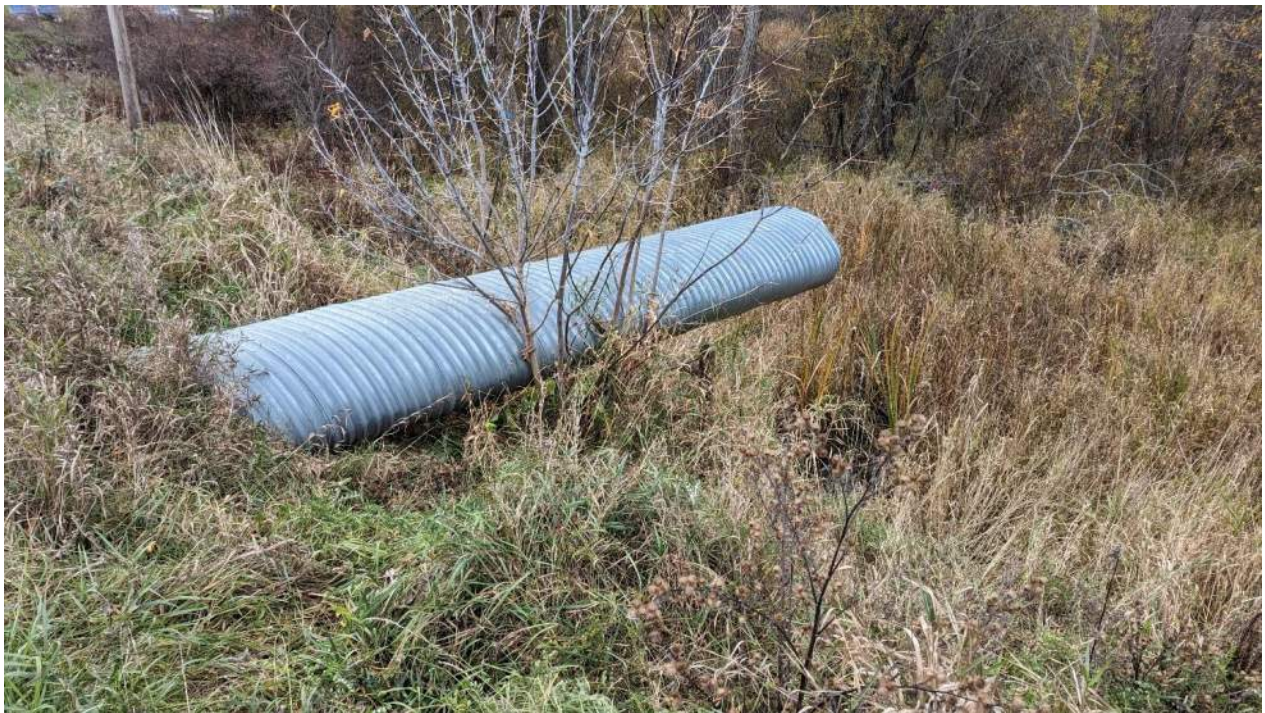
The second auxiliary outlet is located more southerly along the left embankment. The outlet consists of a 24" X 36" pipe-arch CMP culvert. The embankment on the upstream side at the inlet is protected with field stone riprap. The outlet discharges approximately 20 feet beyond the toe of the embankment. The length of the pipe is approximately 65 feet.

Figure 10: Southern Overflow Culvert

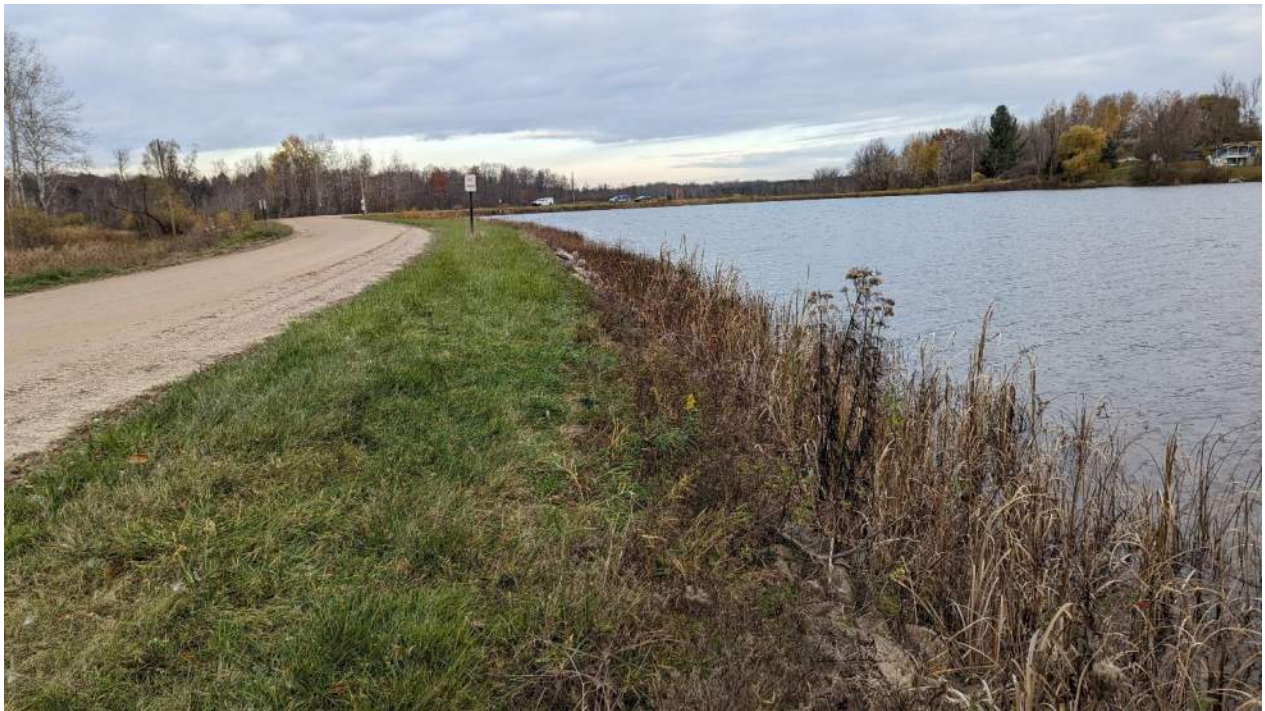
The upstream embankment is protected with field stone rip-rap, and it generally in good condition. There are a few areas southern part of the embankment that some erosion due to waves. These areas should be armored with riprap to prevent further erosion.

Figure 11: Upstream Embankment Looking Right

1. Monitor the inlet access to the primary and overflow spillways monthly and maintain them in a clear condition at all times.
2. Place new riprap in areas of erosion due to wave action on the upstream embankment.

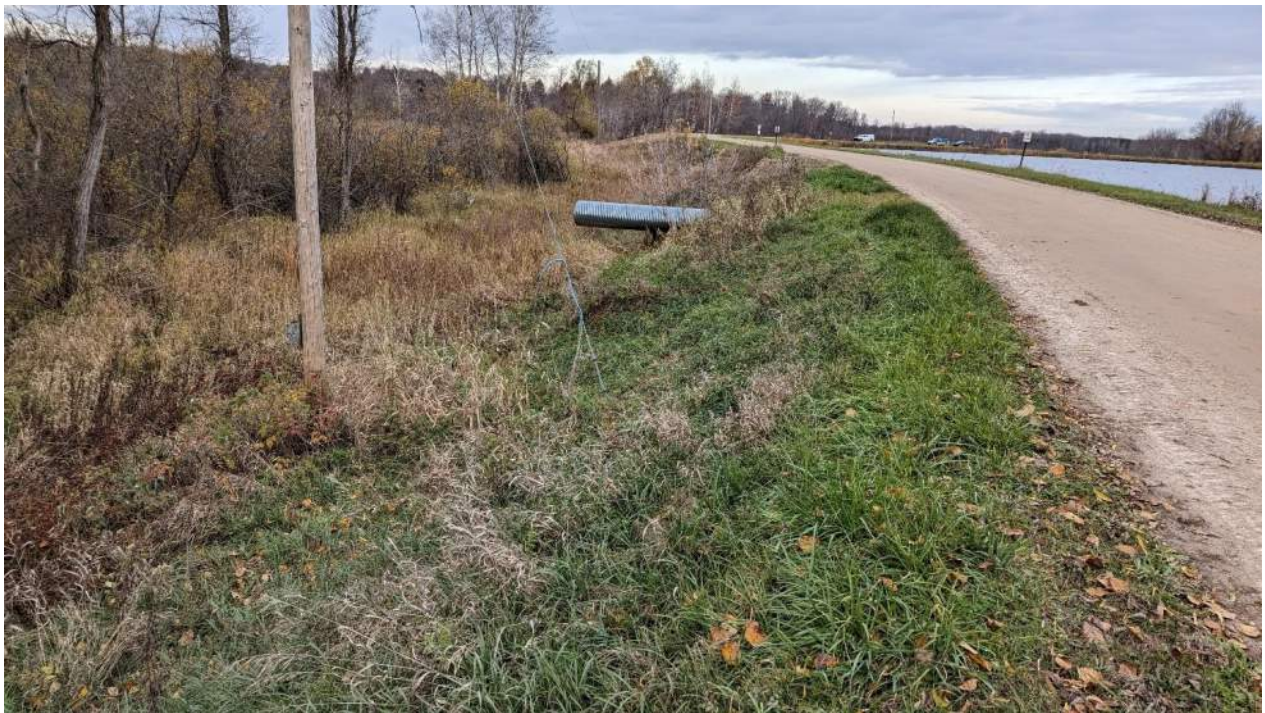
Figure 12: Southern Overflow Pipe and Downstream Embankment, Looking Right

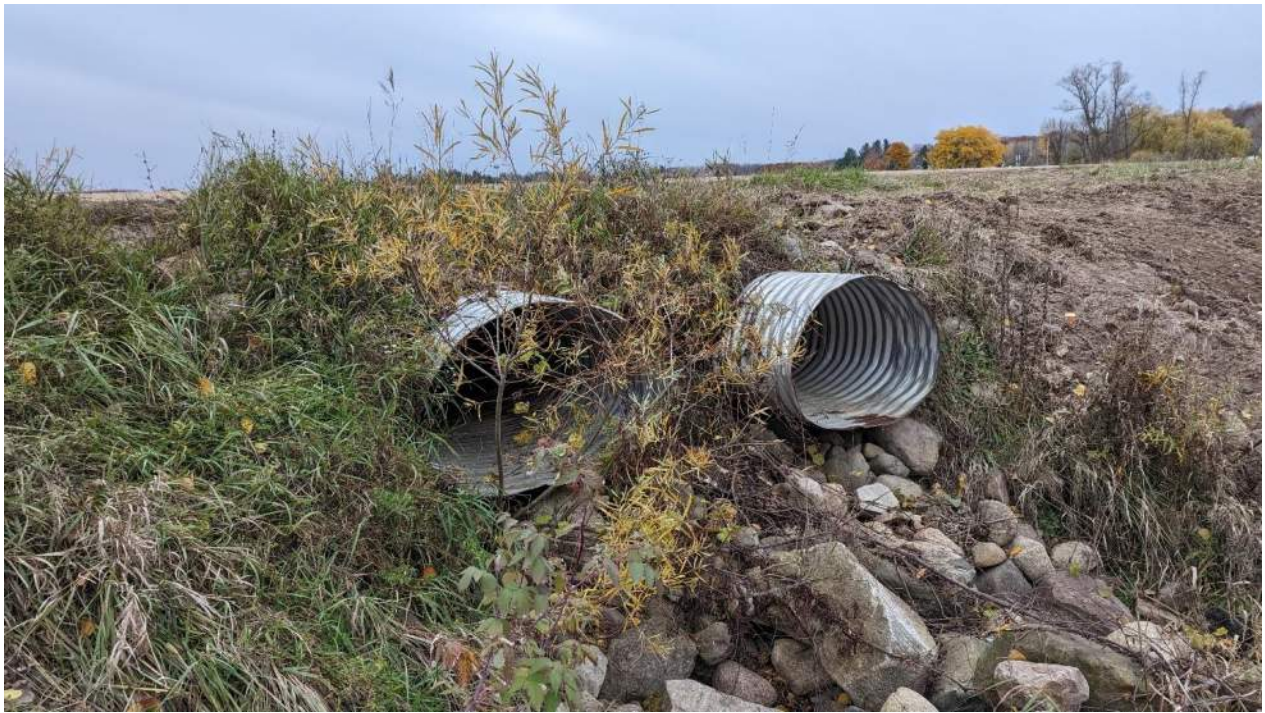
The dam structure also has two auxiliary emergency culvert outlets. Both are located in the left embankment. The first outlet is located near the middle of the dam and consists of two 42-inch wide by 29-inch high pipe arch CMP's. Field stone riprap protection is on the upstream and downstream side of the outlet. The twin culverts are approximately 50 feet long.

Figure 13: Central Overflow - Dual Pipes
